## Kubota V2203 Engine Rebuilding Specialists

The pictures on the following pages depict the major steps in remanufacturing the Kubota V2203 Tier 2 and 3 engine. New parts used in all remanufactured engines include the pistons, piston rings, bearings, governor and start springs, gaskets, valves, valve guides, springs, valve seals, and valve locks. All other parts are inspected and meet Kubota specifications as detailed in their service manual.

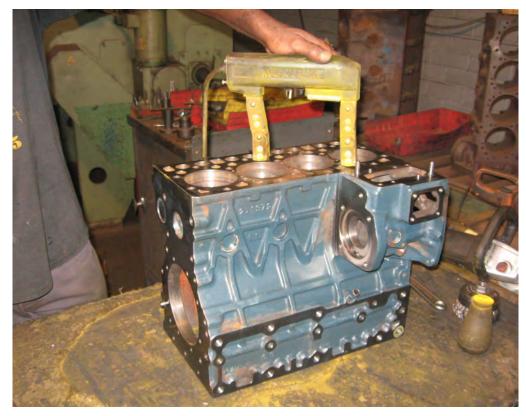
After cleaning and removing old gaskets, block is magnafluxed to detect any external and internal cracks.

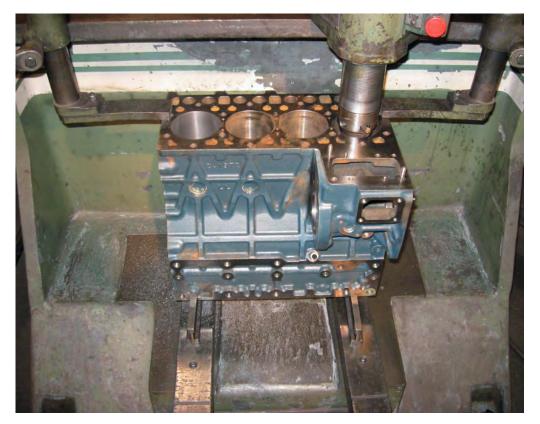
All engines are bored to a maximum .020 overbore or sleeved back to standard bore.

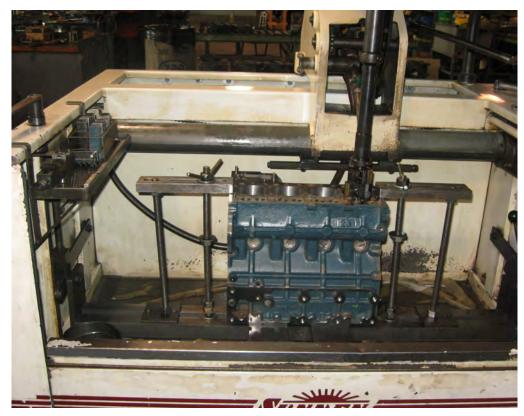
Cylinders are bored and honed to correct size and RA finished for quick ring seating.

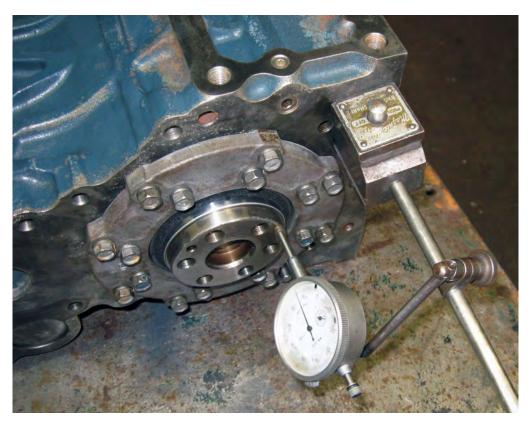
With crankshaft installed, end play, or thrust is checked and adjusted to factory specs.

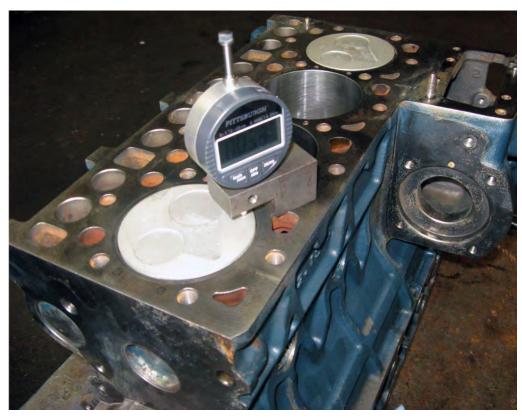
Piston protrusion is checked to install correct head gasket.

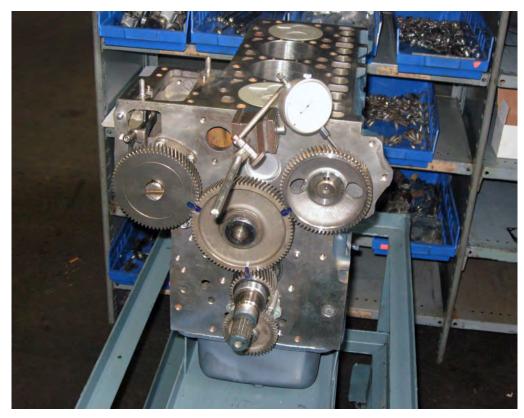
Timing gears are checked for backlash specification.

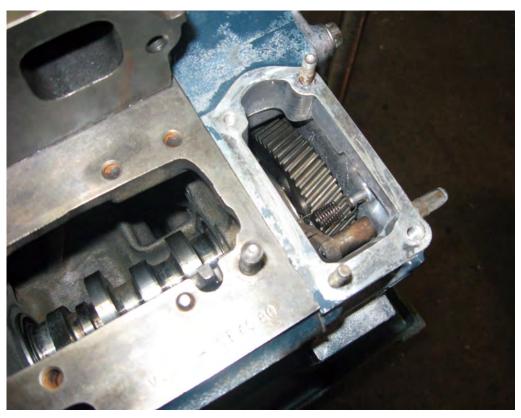
All governor and starter springs installed are new.

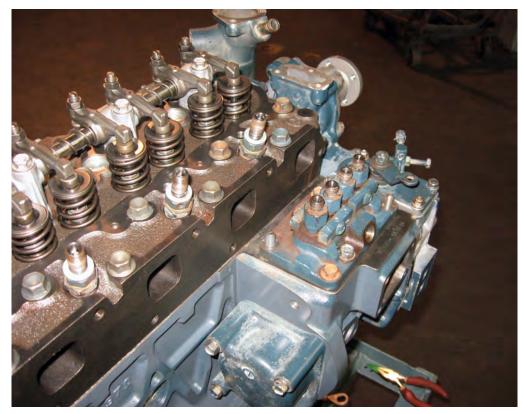
Injector is installed with correct shim pack for fuel pump timing.

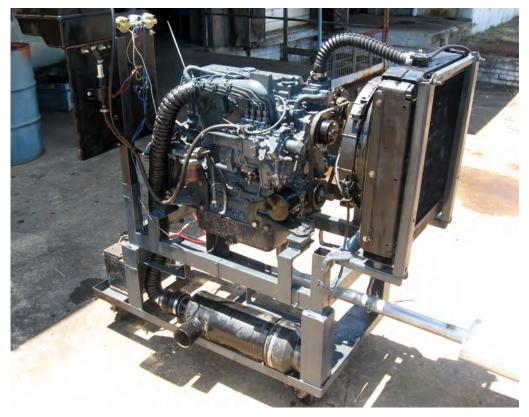
Every engine is live run tested for two hours. Adjustments are made as needed for governor RPM, oil PSI, and water temp, and engine is checked for fuel or oil leaks.

As you can see in the last picture, all our engines are live run to make sure you get a quality engine.
